## The Hows, Whys and Fixes for Pegasus "Jitter"

Recent investigations into the reasons and possible cures of Pegasus screen Jitter have revealed that there are at least 4 distinct causes. This report explains the theory behind these causes and suggests some modifications to erradicate the jitter.

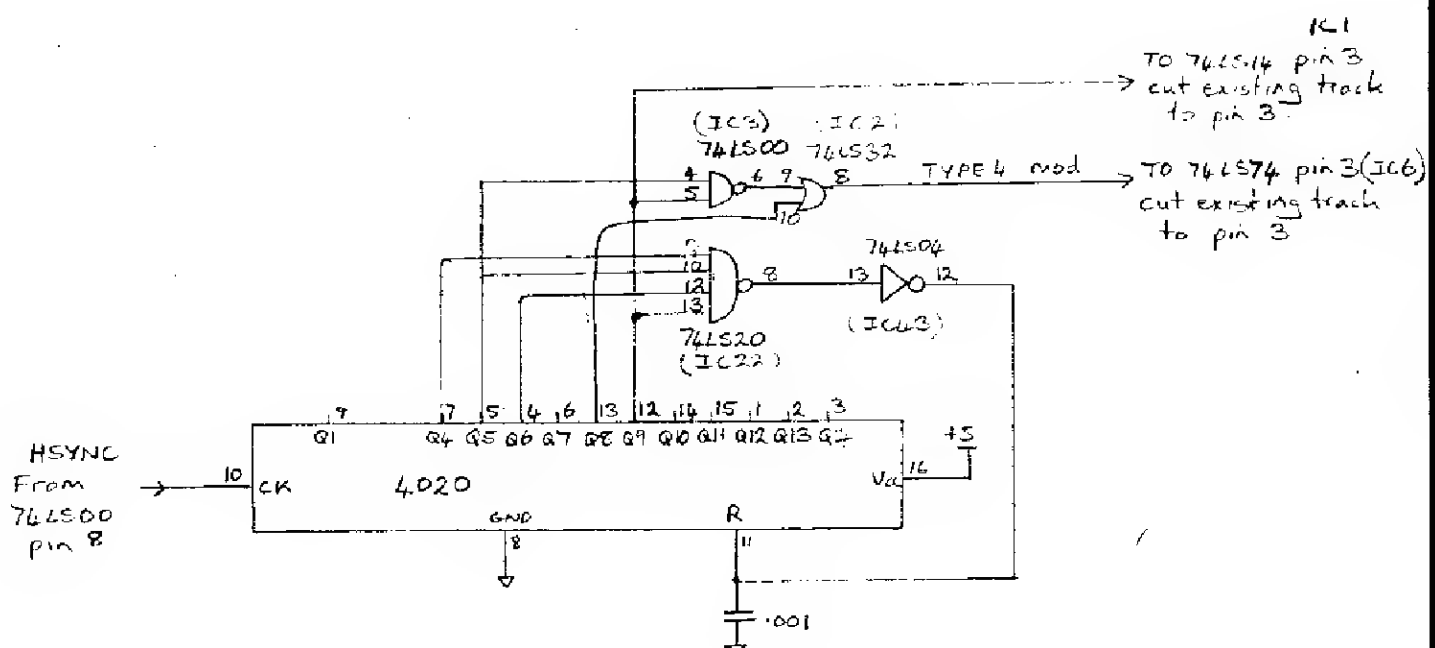
The frame rate for the video is initiated by a signal derived from the mains; Once the frame is started, everything is locked to the processor clock. So while the picture information doesn't jitter with respect to HSYNC and VSYNC, the frames themselves do jitter with respect to each other. In other words the VSYNC signals are not regular. Sometimes they are  $X \times 64 \text{ us}$  (HSYNCS occur every  $64 \text{ us}$ ) apart and sometimes they are  $(X + 1) \times 64 \text{ us}$  apart. Normal TV sets have an oscillator which likes to lock to regular VSYNC pulses. It will infact lock to a frequency with a period somewhere between  $X + 1$  and  $X$  times  $64 \text{ us}$ . Then what you get is a picture sometimes slightly above and sometimes slightly below the true position. The cure is to use some kind of divider to derive your 50Hz from the processor clock, instead of the mains. The following mod uses one IC and some existing gates on the Pegasus board.

The 74LS20 gate has tracks running to it which must be cut.  
 The 74LS04 becomes free from a modification to the dot clock  
 oscillator which was given to us by G. Barbour of Christchurch.  
 This modification stops shimmer on the displayed characters  
 and stabilizes the oscillator frequency.

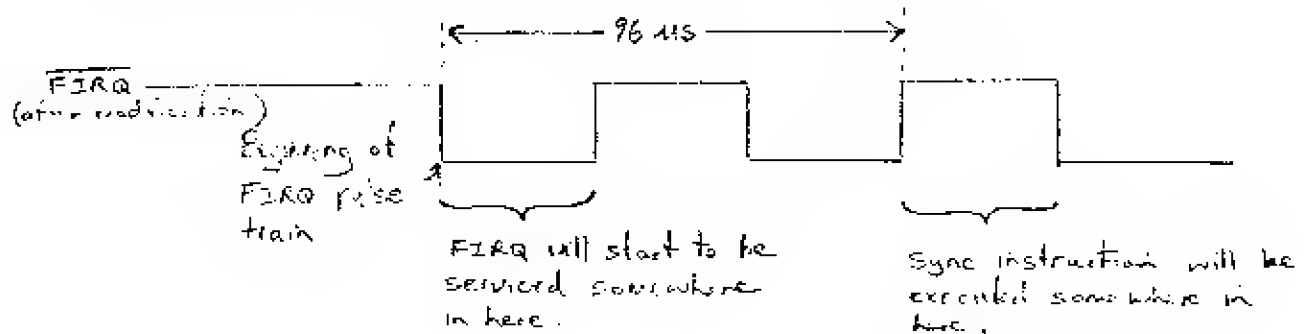
The FIRQ pulses generated by the existing Pegasus hardware are 8  $\mu$ s long. The 6809 chip however only checks the FIRQ pin after each instruction. Since 6809 instructions can take up to 20  $\mu$ s it is clear that it is possible for the chip to miss on FIRQ pulse. If it "sees" the following one then the whole picture will be 64  $\mu$ s too late i.e. one scan line too low on the screen. This causes jitter whenever programs with longish instructions are running.

From this drawing it can be seen that 32  $\mu$ s is the ideal length for the FIRQ pulse (which is active low) because it gives an equal mark space ratio square wave. If the FIRQ pulse were any longer, then the period in which the FIRQ line is high becomes correspondingly shorter and it<sup>is</sup> then possible for the SYNC instruction to occur while the FIRQ line is low, giving sideways jitter.

If the FIRQ pulse is shorter than 20  $\mu$ s it is possible for them to be missed by the processor. In fact the full 32  $\mu$ s is better because it allows the programmer to mask off FIRQs for two or three instructions if he wishes, without missing an FIRQ.

The cure for Type 2 jitter is to take the FIRQs from the 74LS93 divider, IC7 pin 9. This is a square wave with 32  $\mu$ s each way. This modification also needs a new monitor version 2-3. The delays in this monitor are adjusted so that a) the picture is in the middle of the screen and b) the SYNC instruction is 96  $\mu$ s after FIRQ starts to be serviced. This ensures that the SYNC instruction is not executed while the FIRQ line is low, which would cause terrible sideways jitter.

So 32 us FIRQs are used. The time from the start of servicing of the FIRQ to the SYNC instruction in the monitor is adjusted to be 96 us. Also since the new FIRQs are out of phase with the old ones, the monitor has its delay that positions the picture in the middle of the screen adjusted.

The actual modification is done by cutting the track to the 202 74LS32 pin 5 and jumping this pin to the 74LS93 pin 9 (IC7) and getting a version 2-3 monitor.

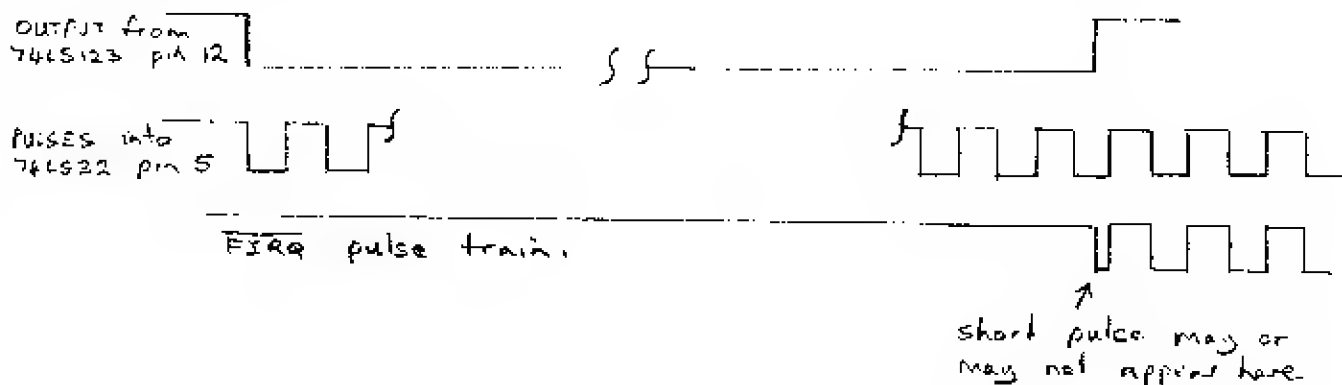
The timing from the VSYNC pulse to the start of the FIRQ burst of pulses is done by a 74LS123 one - shot. The delay is approx 3 ms, and since this is timed from an R-C network it cannot be set accurately. If the end of the delay comes during the time that the FIRQ pulse is low, then a small FIRQ pulse will be given to the processor before the burst of full length ones.

Since the pulse can be very short the processor may or may not "see" it. The 123 delay drifts with time and so the jitter will come and go.

The cure is to clock IC46 b with FIRQ pulses instead of E. This F/F is redundant as it is anyway. The existing track to the 74LS74 pin 11 (IC46) cannot be cut as it is underneath the IC. Instead it must be cut in two places and then 2 jumpers need to be put in.

Cut the track running from IC46 pin 11 to the system PIA pin 25 and also cut the track running from IC46 pin 11 just before the hole where it goes through the board and on to pin 3 of the 74LS04 oscillator. (IC43). Now join this hole back to the PIA pin 25. Now join IC46 pin 11 to the 74LS32 pin 5 (IC2). Note that this half of IC46 does not appear in the drawings but it is used in the circuit.

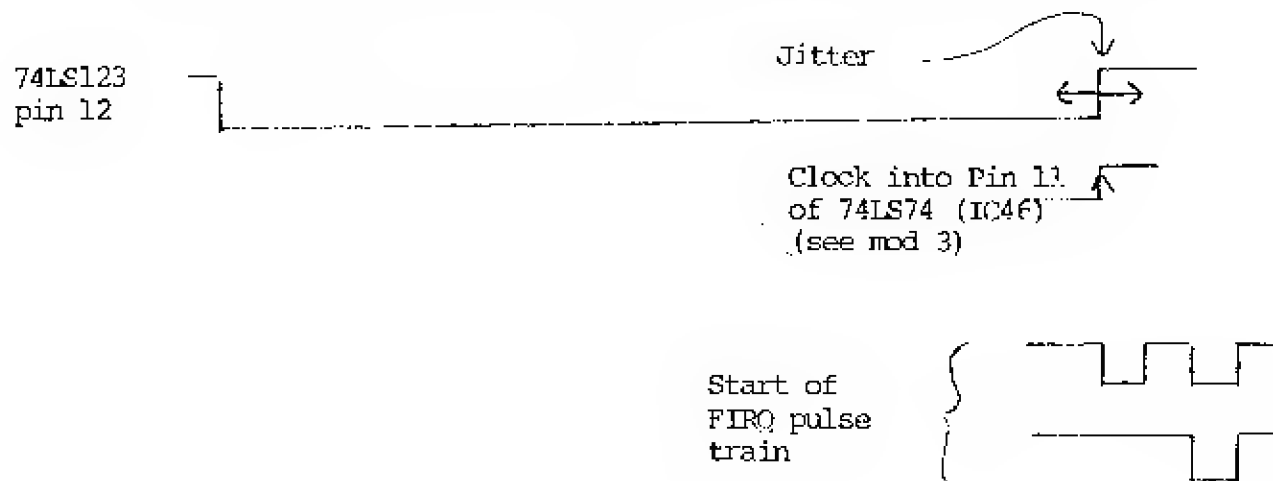
Type 4 jitter is again caused by the 74LS123. Using an oscilloscope it can be seen that a noticeable jitter occurs in the delay pulse whenever the Pegasus is running a program. When the trailing edge of the pulse falls on or near the clocking point explained for type 3 mod then the jitter in the 123 will cause the first FIRQ pulse to appear sometimes latter and sometimes earlier.

The only way to get round this is to bypass the 74LS123 altogether and use some pulses derived from the Type 1 jitter mod. (see the drawing for the 4020 mod). The existing track to 74LS74 IC6 pin 3 must be cut and taken to the spare nand gate as shown. This will give a picture nicely in the middle of the screen. (vertically)
